# Newsletter June, 2015

# WHERE THE EARTH MOVED – SEDLING MINE COLLAPSE, AUGUST 2014

#### **Brian Young**

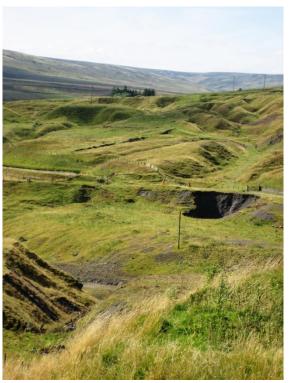
Figure 1.

The crown hole viewed from the east. Old surface workings on Sedling Vein, close to the position of Sedling Shaft, may be seen in the bottom left of the picture. Parts of the extensive surface Queensberry Ironstone Workings associated with Breckonsike and Burtree Pasture veins are seen beyond the crown hole. *Photo: B.Young*

The recent crown hole lies above the long-abandoned western group of stopes in Sedling Vein that were worked for lead ore by W B Lead. I have been unable to establish whether any more recent re-working or exploration for fluorspar took place in this part of the vein during the Weardale Lead Company's occupancy. These extensive western stopes were worked on both sides of the burn from beds extending from the Great Limestone near the surface to the Slaty Hazle sandstone beneath the Five Yard Limestone at a depth of around 120 m below the burn.

As discussed above, whereas the widths of the old lead stopes beneath the crown hole are not recorded by Dunham (1952 and 1990), it is likely that they may, at least locally, be of comparable dimensions to those in the more recent fluorspar workings. Together with

their likely aggregate height in places of up to 60m, these void spaces at the depths of the mine workings here, are quite capable of creating a substantial surface crown hole in the event of their collapse.
